# Manhole Inspection Summary

Manhole # S25I\_\_017MH

Insp Date: **5/11/09 7:55 AM**

**Location** Address: **104 CARLTON**

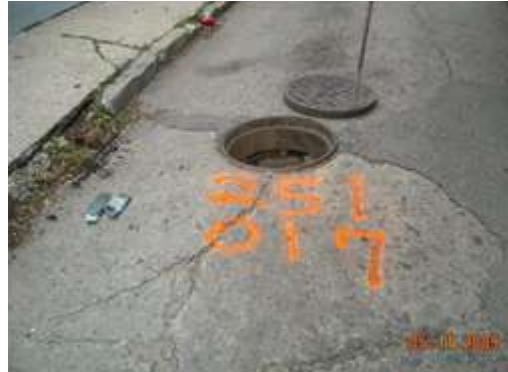
Location View

PAVEMENT MARKED

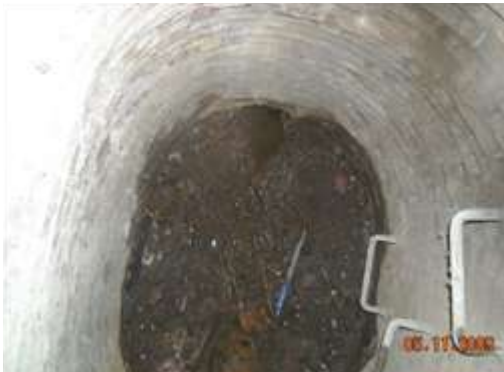
Defect 3

Condition: ☐ Sound ☐ Cracked ☐ Root Intrusion ☐ Deteriorated ☐ Leaks ☒ **Debris**

DEBRIS IN TERMINAL CHANNEL

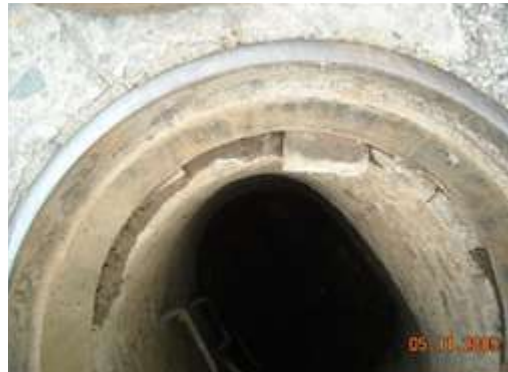
Defect 2

Offset: **2.5** (in.)

FRAME OFFSET

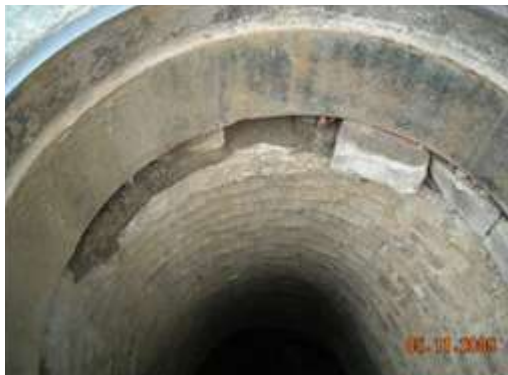
### Defect 1

Condition: ☐ Sound ☐ Cracked ☐ Root Intrusion ☒ **Loose Brick** ☐ Deteriorated

LOOSE CHIMNEY BRICKS

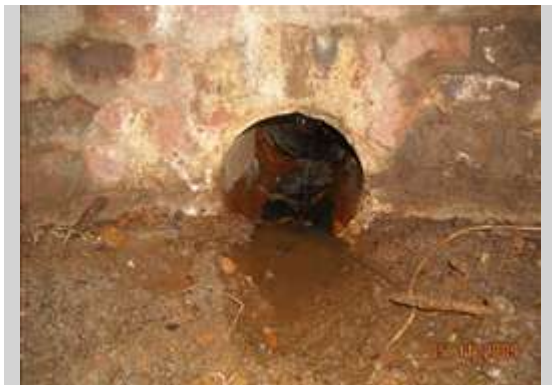
12 O'Clock Outflow

8 in. Circular Gravity Sewer  
Pipe Out @ 12 O'Clock

Invert Depth: **8.95** (ft.) Flow Characteristics: **Slow**

Infiltration: **None** Pipe Seal Cond: **Sound**
